CONSTRUCTION STORMWATER GENERAL PERMIT INSPECTION REPORT

State of Washington Department of Ecology

The Electron Hydro LLC Intake project is covered under the State of Washington's Construction Stormwater General Permit (CSWGP). The CSWGP is a National Pollutant Discharge Elimination System (NPDES) and a State Waste Discharge permit for discharge of construction-related stormwater. The purpose of this inspection is to conduct a compliance inspection and to provide technical assistance as appropriate. Ecology had previously been to the site a few years' prior, during the JARPA review for the then proposed re-construction of the barrier dam and intake structure; and on 11 August 2020 in response to ERTS699710; and 17 August 2020 for a CSWGP compliance inspection; and 21 September 2020 partial CSWGP compliance inspection and response to ERTS 700385 and 700706.

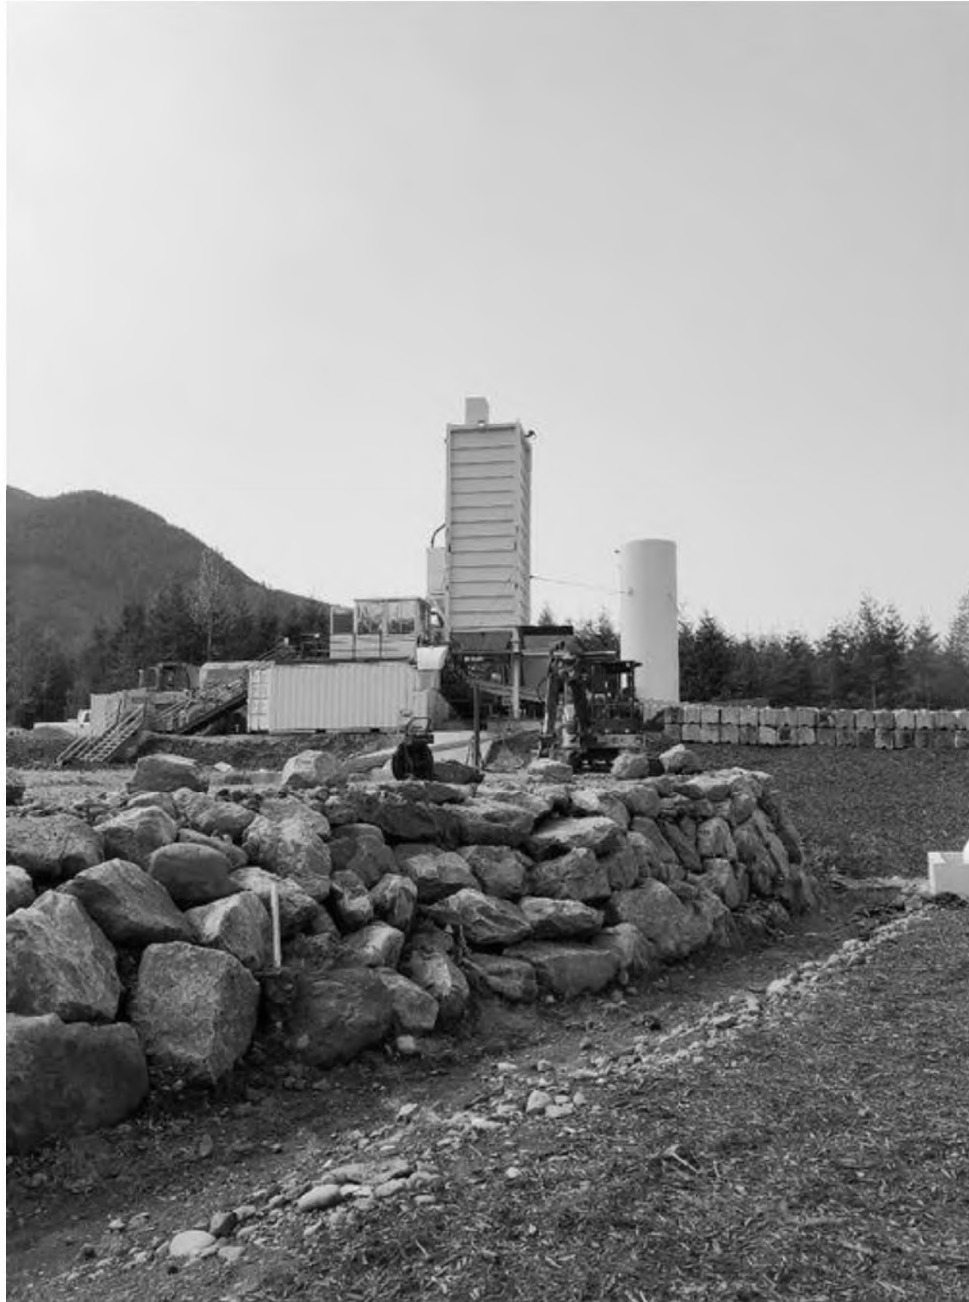
Photo 2

Photo Description: General upland staging area view

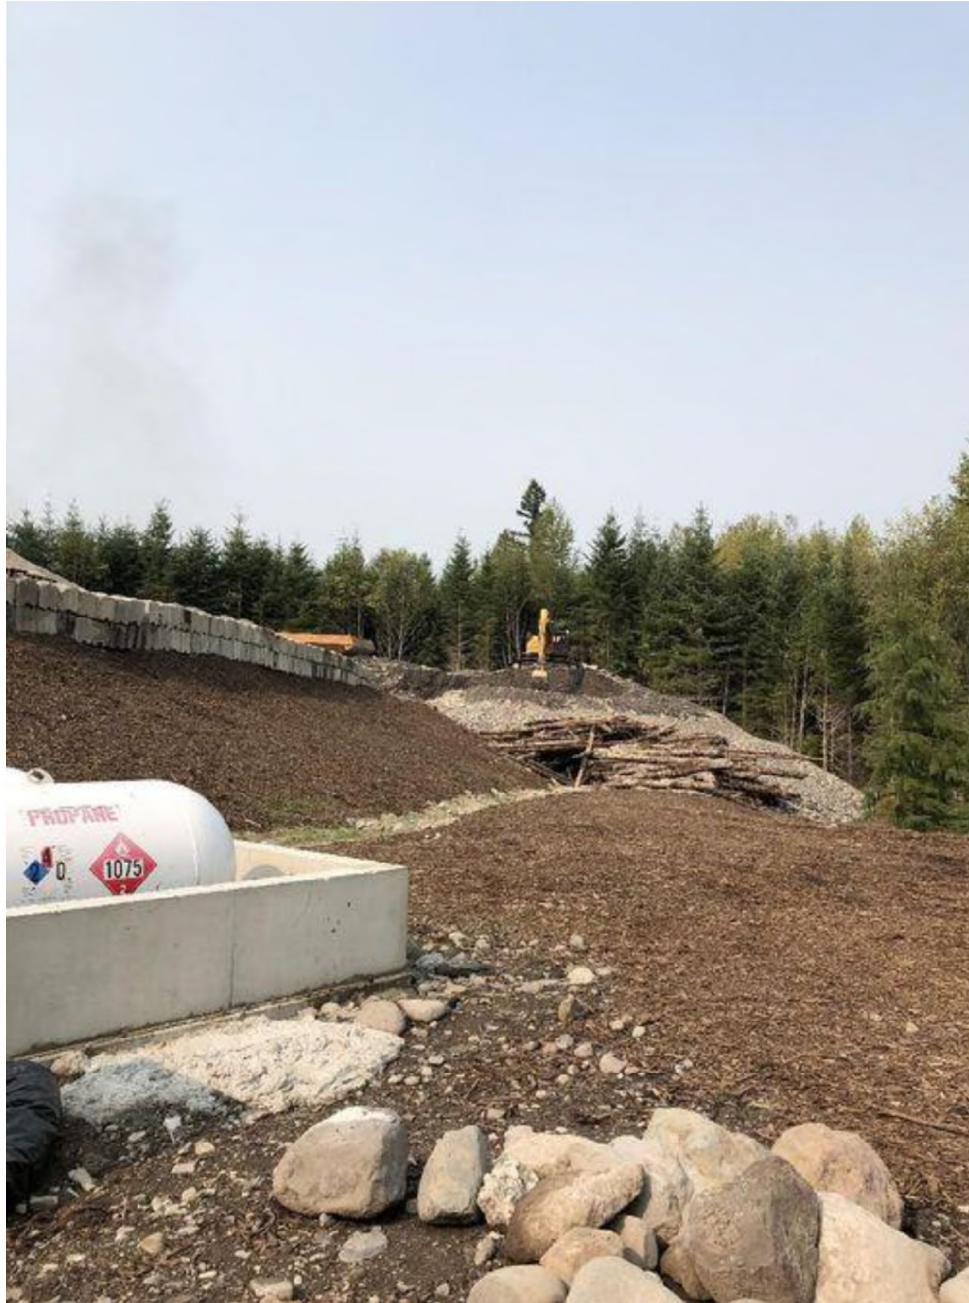
Photo 3

Photo Description: General upland staging area view

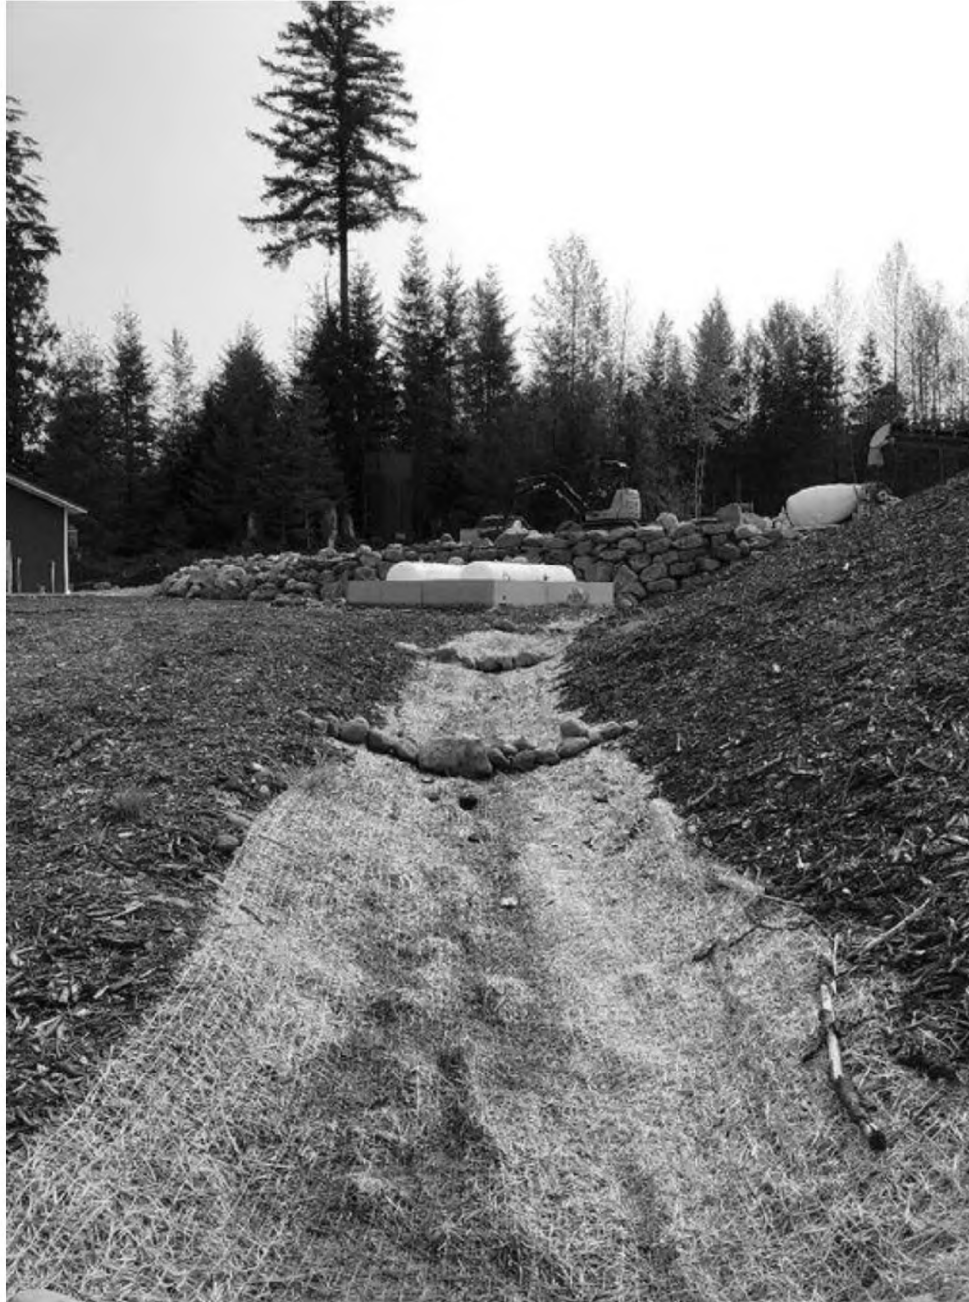
Photo 4

Photo Description: Plastic mesh should be removed prior to heavy rains. Potential conveyance channel for treated pH water.

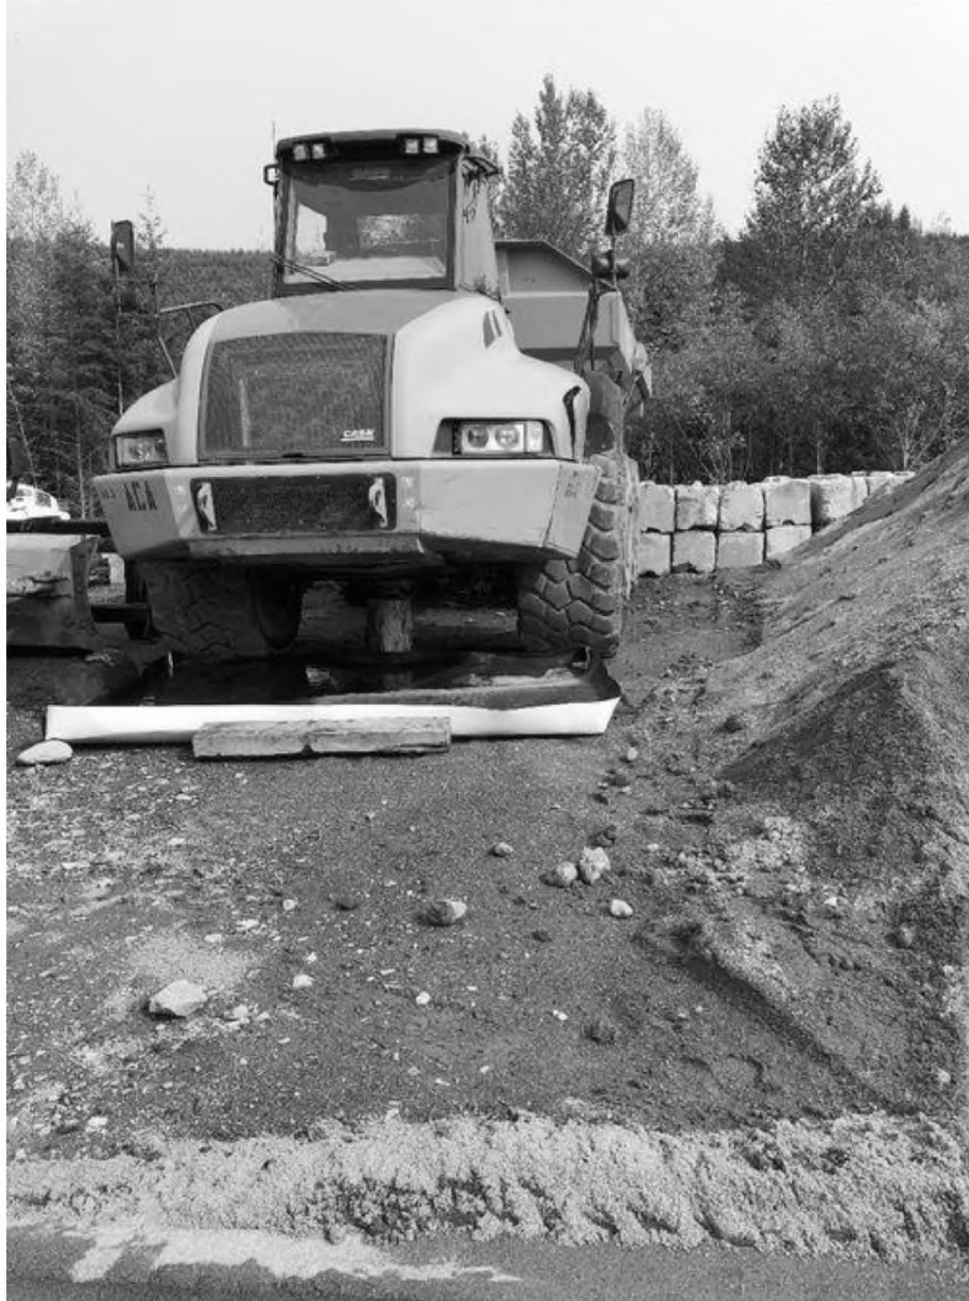
Photo 5

<p><u>S9.D.11 Maintain BMPs</u> Unmaintained haul road stabilization, unmaintained secondary containment observed beneath fuel tanks, and unmaintained ditch check BMPs in "conveyance ditch." Failure to meet S9.D.11.a: Permittee must maintain and repair all temporary and permanent erosion and sediment control BMPs as needed to assure continued performance of their intended function in accordance with BMP specifications. Maintain and repair all temporary and permanent BMPs, as set forth in permit condition S9.D.11.a.</p>	<p>Immediately begin. Address the problems no later than 10 days from the date of this inspection.</p>	<p>SWMMWW, Chapter II-4 Best Management Practices Standards and Specifications, C150, C160</p>
<p>For assistance with any of these compliance issues or recommendations regarding BMPs, please see the 2014 Stormwater Management Manual for Western Washington (SWMMWW), Volume II, Construction Stormwater Pollution Prevention which includes BMPs for Source Control and Runoff Conveyance and Treatment BMPs. The full SWMMWW is available at: http://www.ecy.wa.gov/programs/wq/stormwater/manual.html.</p> <p>The Department of Ecology has the authority to issue formal enforcement actions including issuance of orders and civil penalties of up to \$10,000 per day per violation for violations of your NPDES permit and/or state laws and regulations.</p> <p><i>Noncompliance with the limits, monitoring requirements, terms and/or conditions established in your permit may result in formal enforcement action by the Department of Ecology.</i></p>

Photo Description: Unmaintained secondary containment

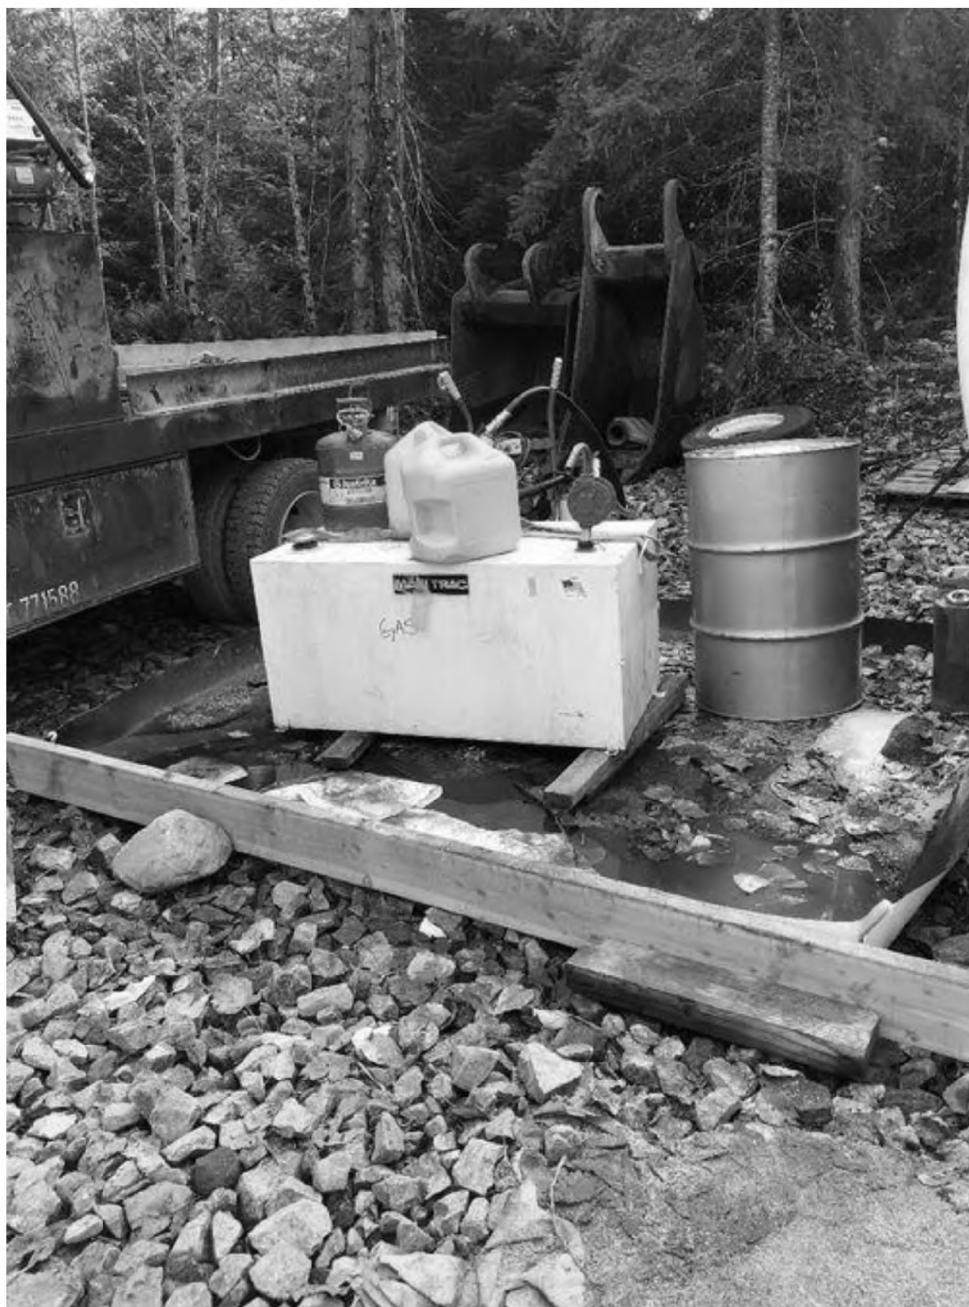
Photo 7

Photo Description: Secondary containment without 110% capacity and side walls need to be maintained.

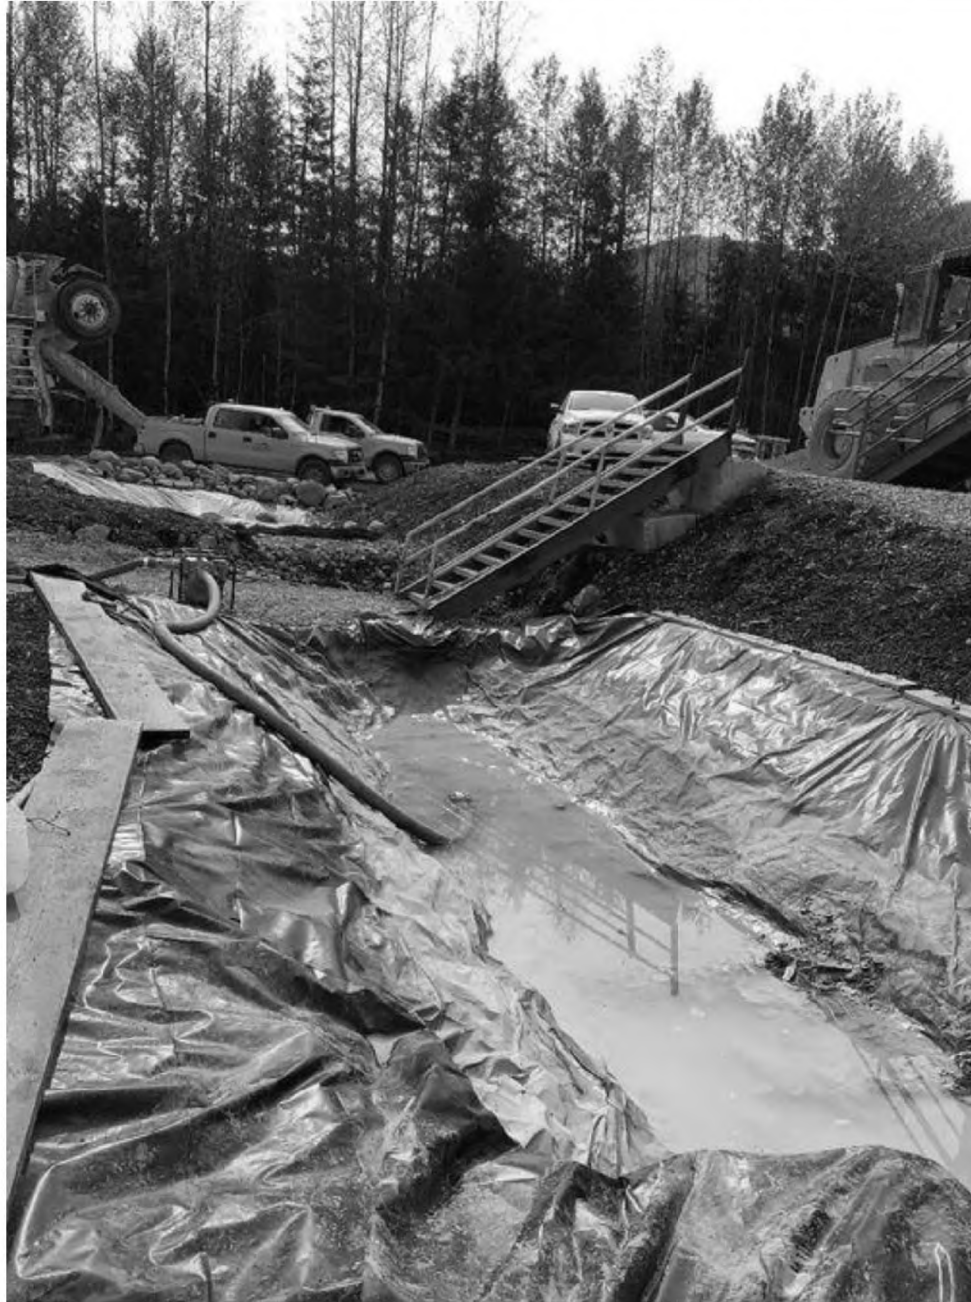
Photo 8

Photo Description: Concrete waste water treatment system- Thom Fischer demonstrated how CO2 sparging treatment system operates.

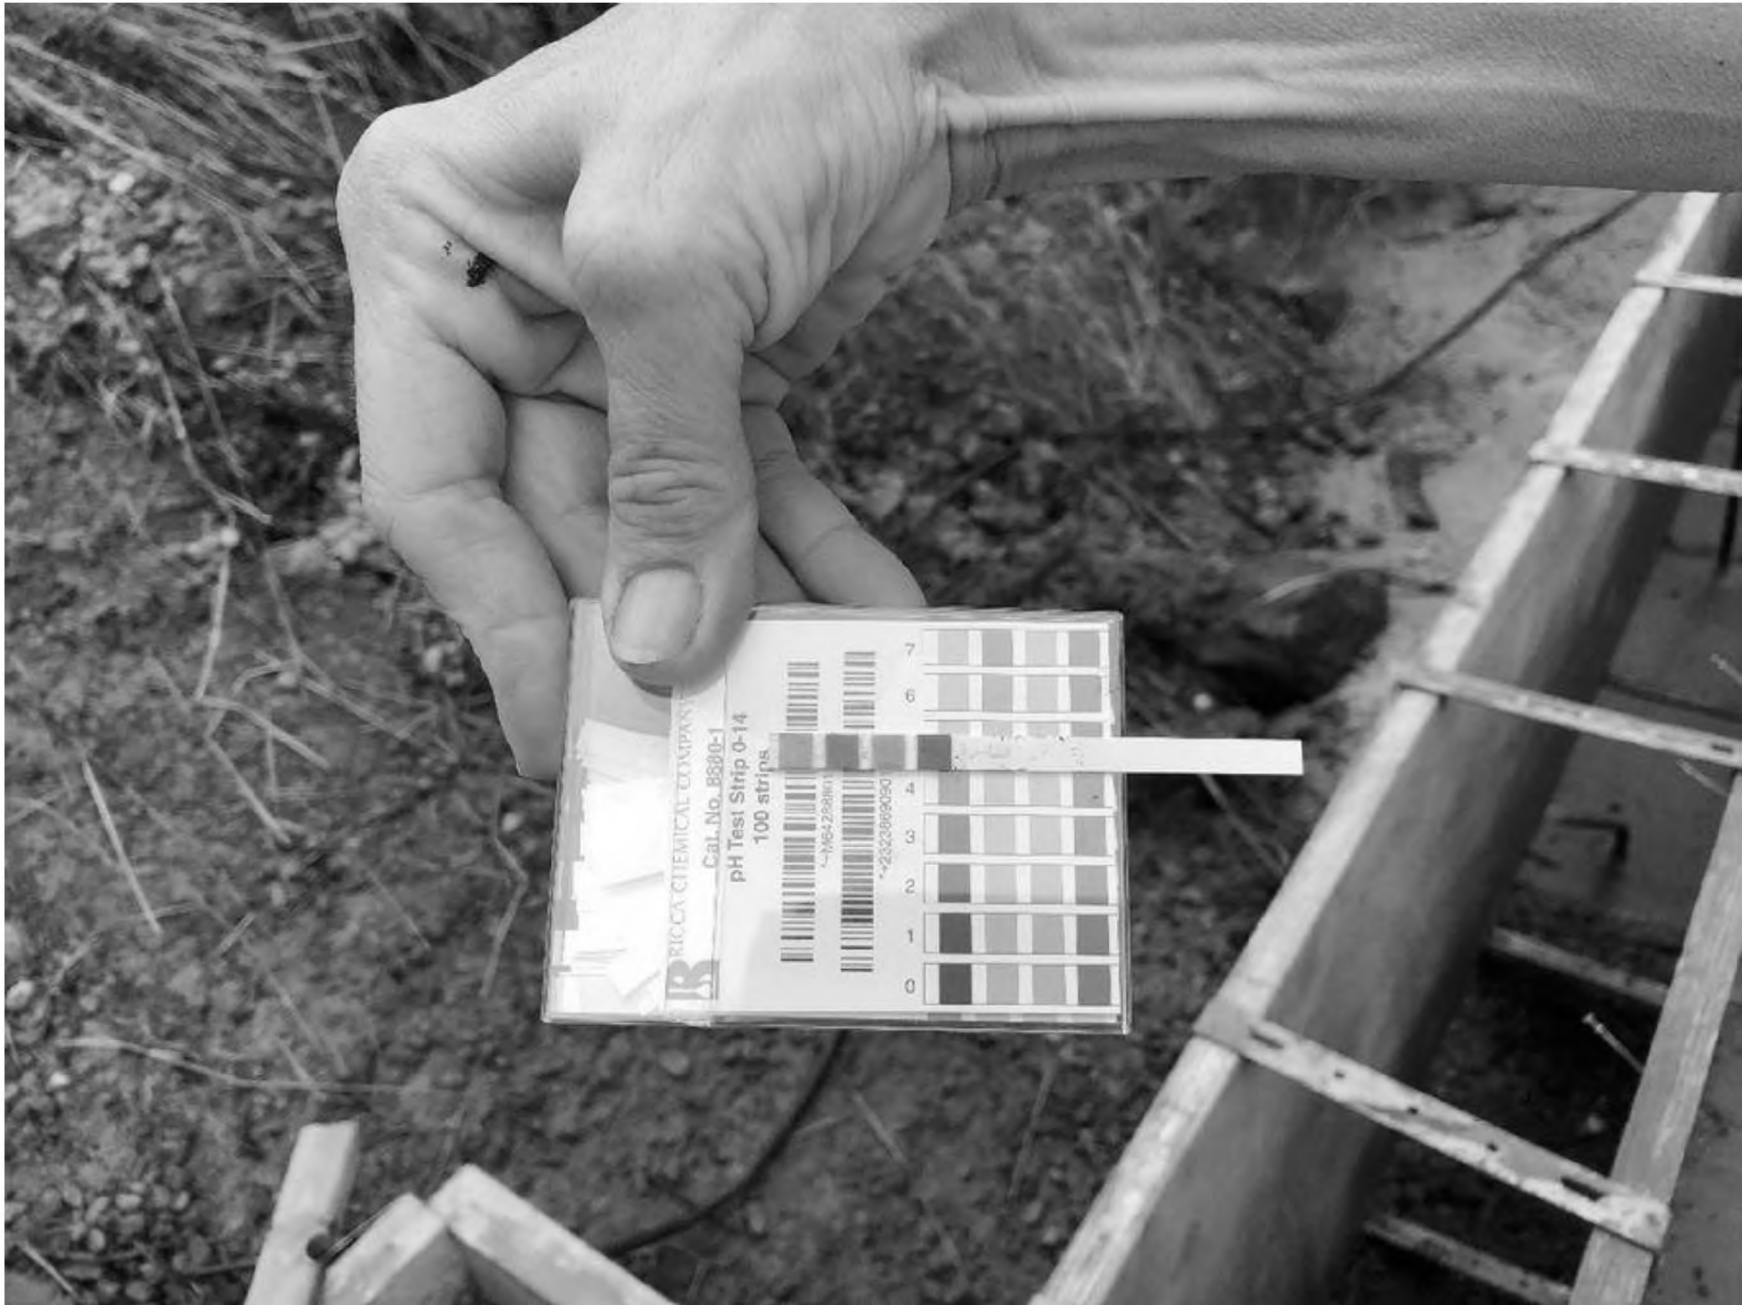
Photo 9

Concrete stairs had been poured, and exposed and unworked soil on steep slope is stabilized. Water at base of staircase was sampled with a 6.5 pH (Ecology sampled) result.

Photo Description: pH sampling result at base of recently poured concrete staircase

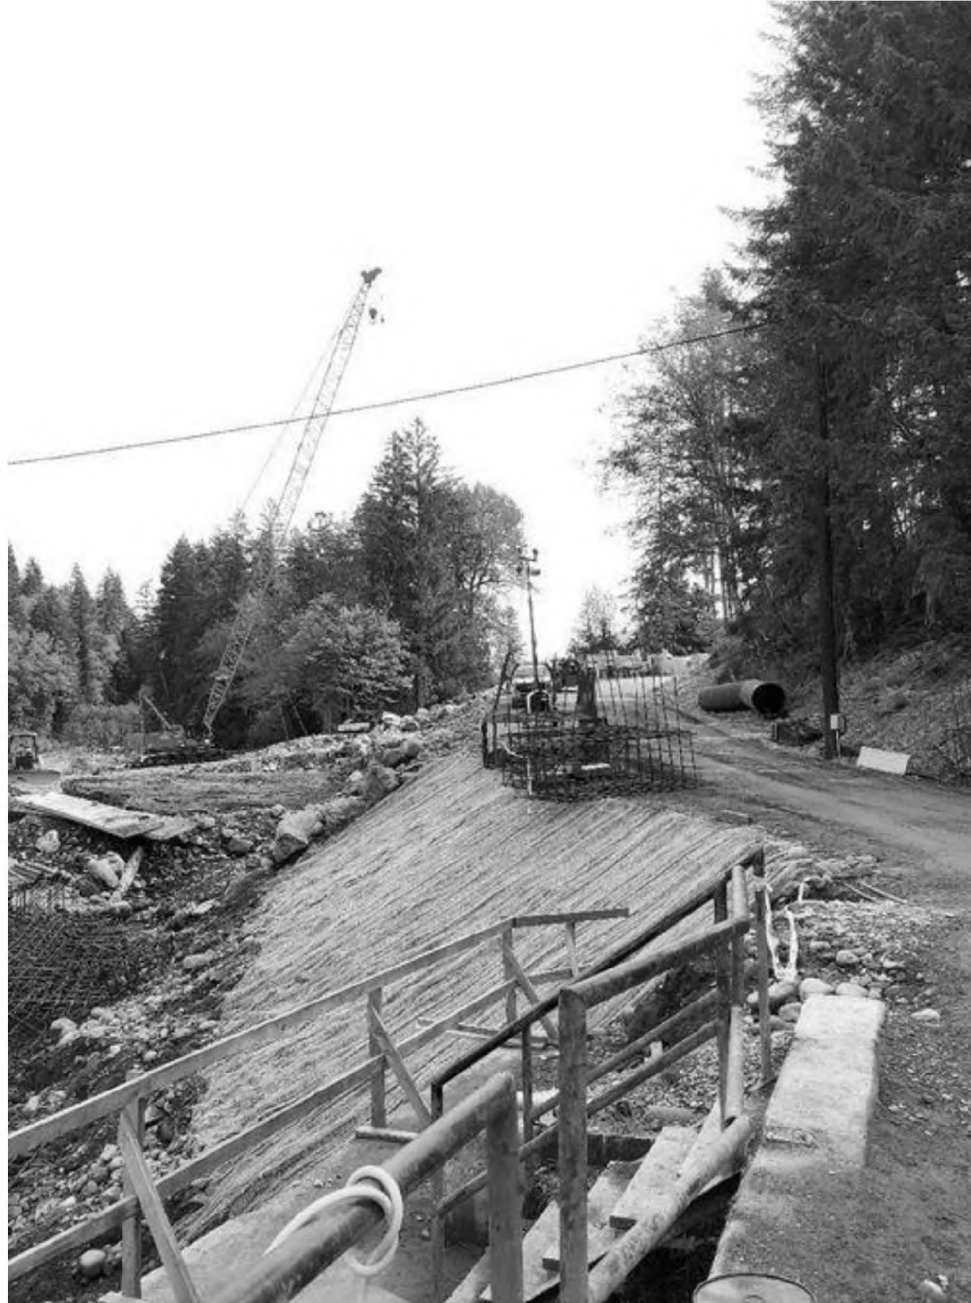
Photo 10

Haul road gravel needs maintenance for stabilization; adjacent slope to the intake structure is stabilized with jute mat. Work consisted of intake structure dewatering, with mitigation efforts to prevent water from travelling underneath hillside and entering the work area. Monitoring was being conducted 300ft downstream of construction activity.

Photo Description: Stabilized slope, unmaintained haul road stabilization

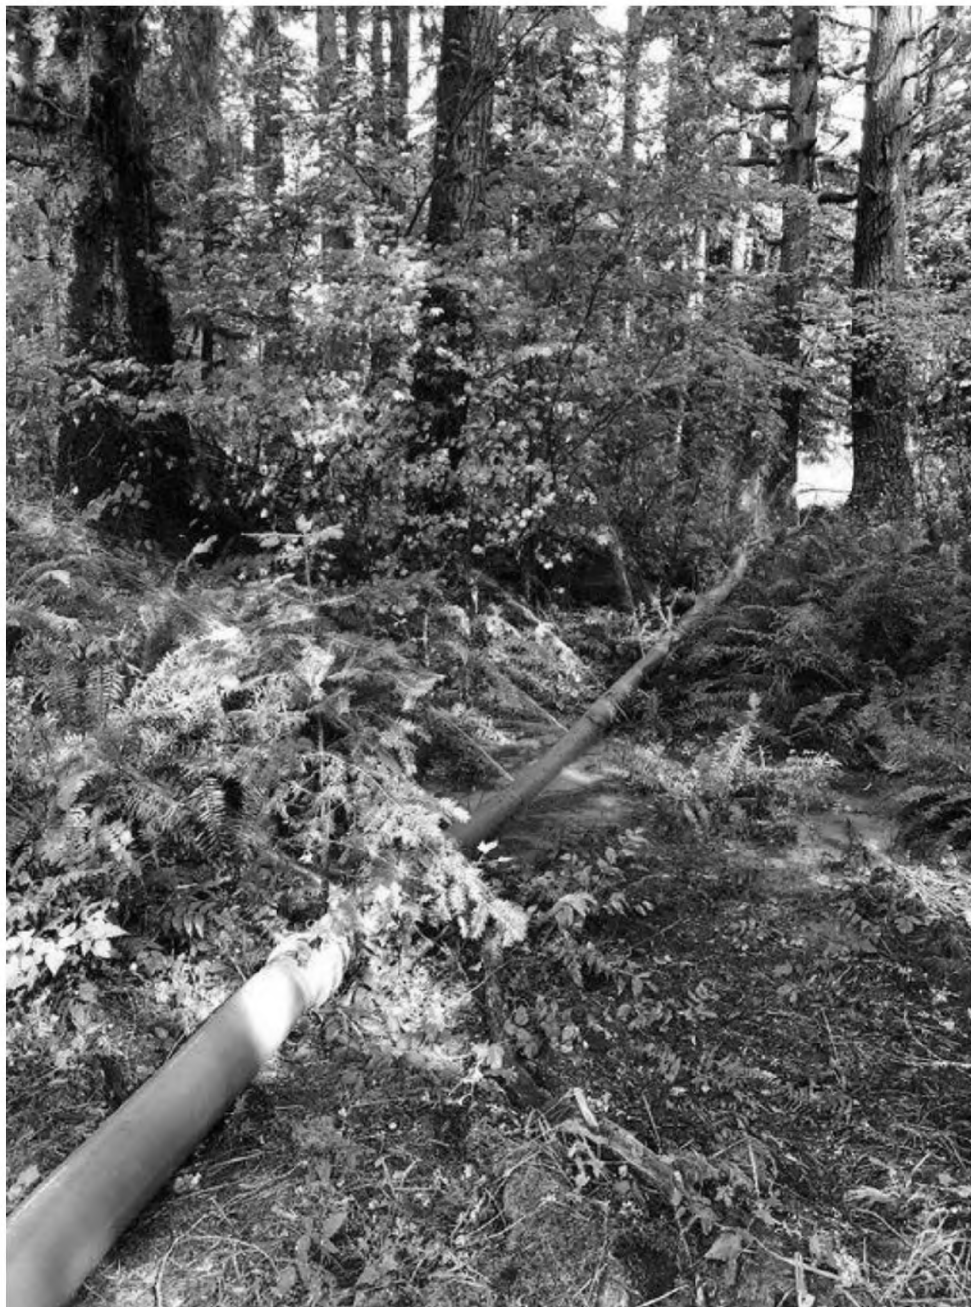
Photo 11

Stormwater from the stormwater conveyance system is being dispersed into the "forested uplands" area. PH analysis was also conducted at this point, with a result of 6.5 (Ecology sampled).

Photo Description: Forested uplands area where stormwater is infiltrated

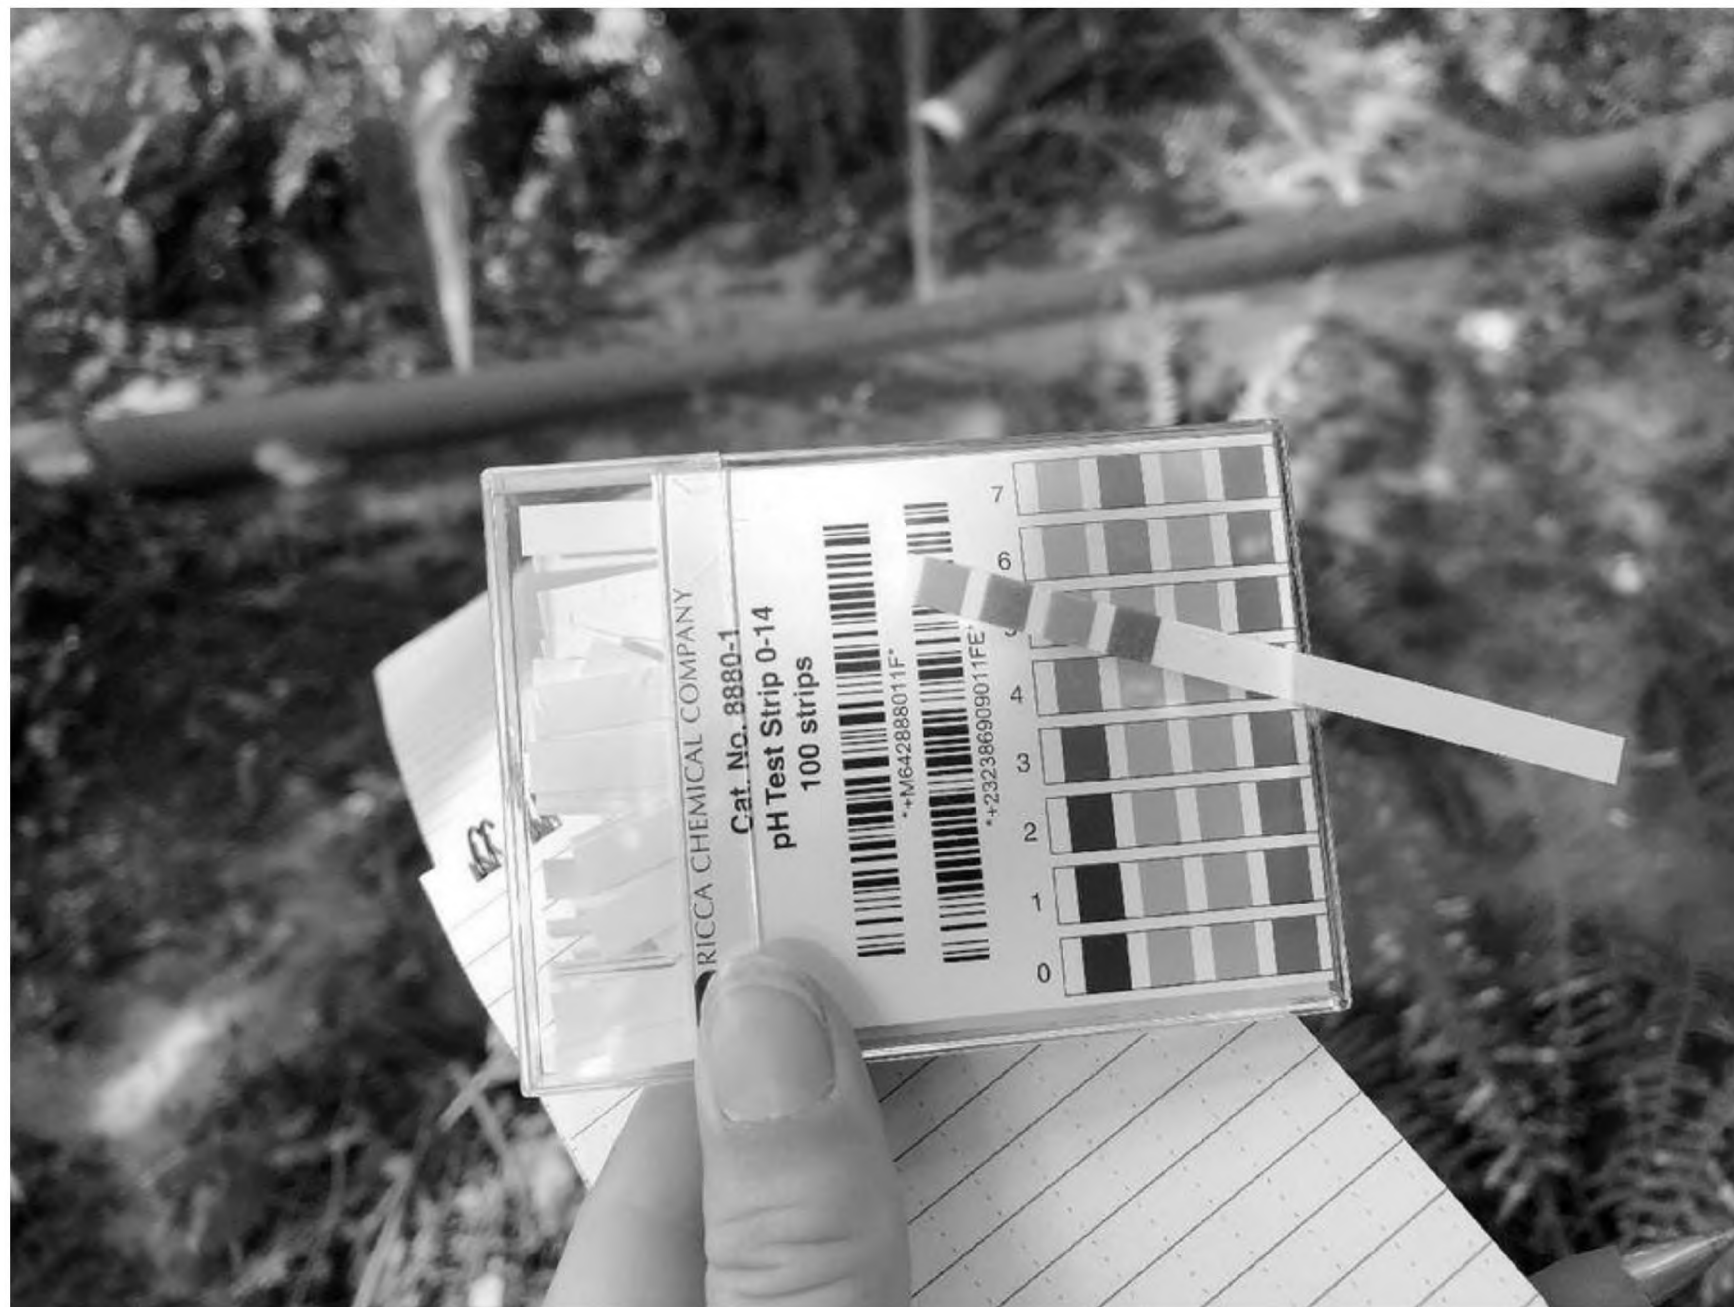
Photo 12

Photo Description: pH sampling result at forested uplands area

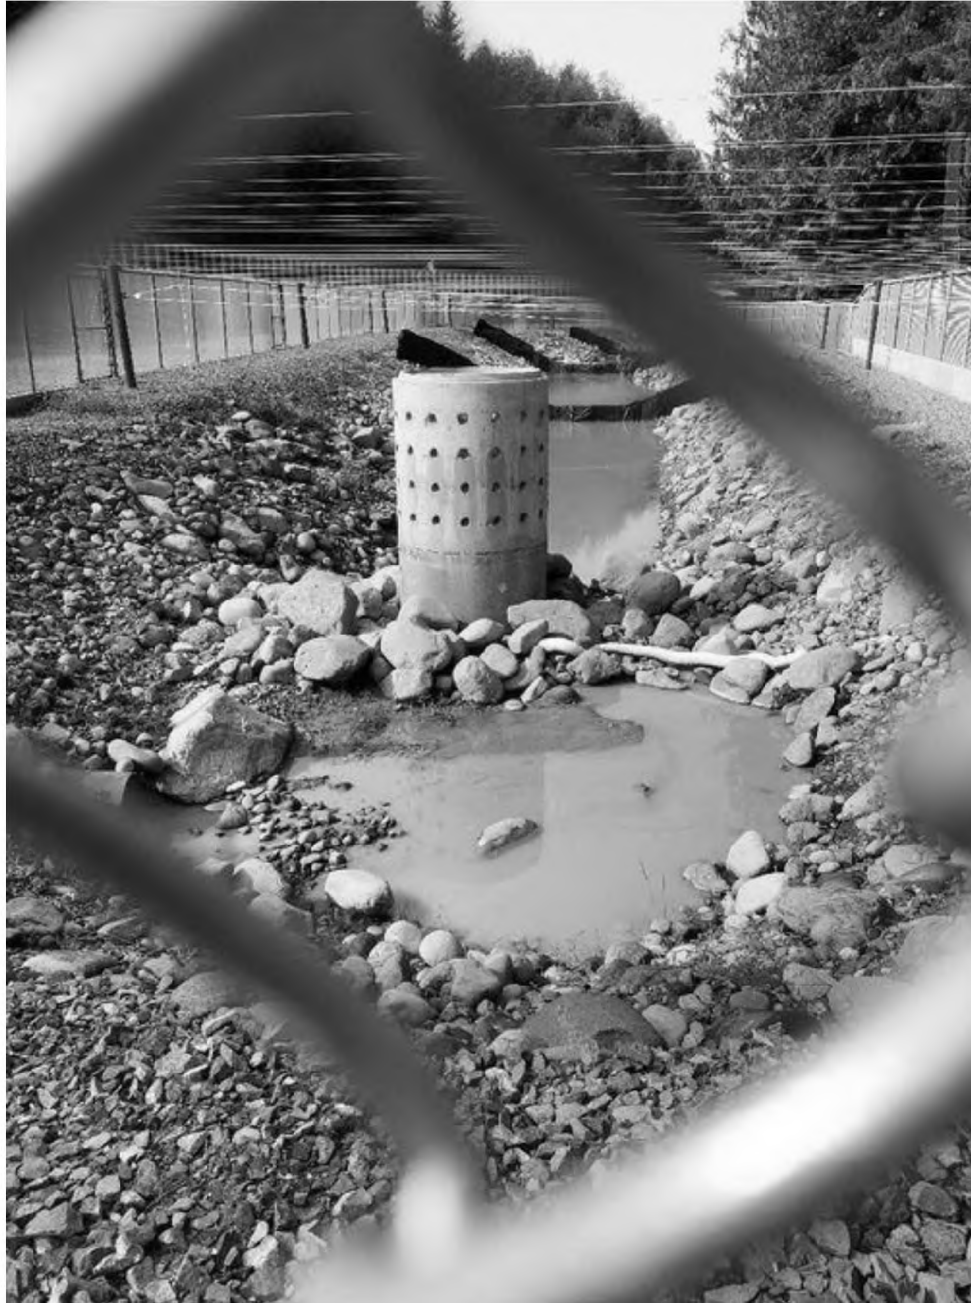
Photo 13

Photo Description: Sediment pond, no longer being utilized for stormwater management

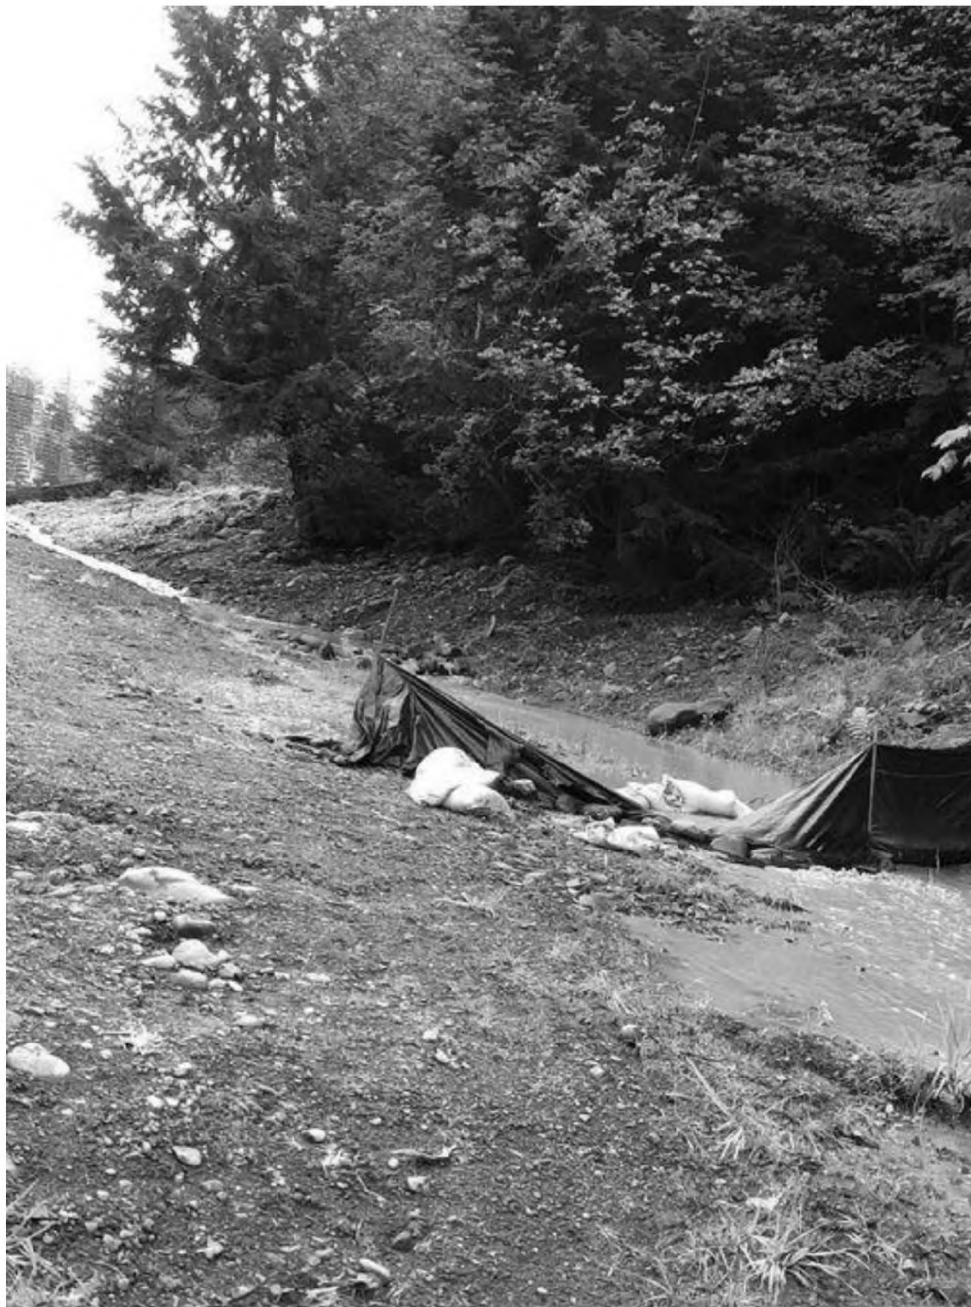
Photo 14

Photo Description: Unmaintained ditch checks in conveyance ditch leading to sediment trap

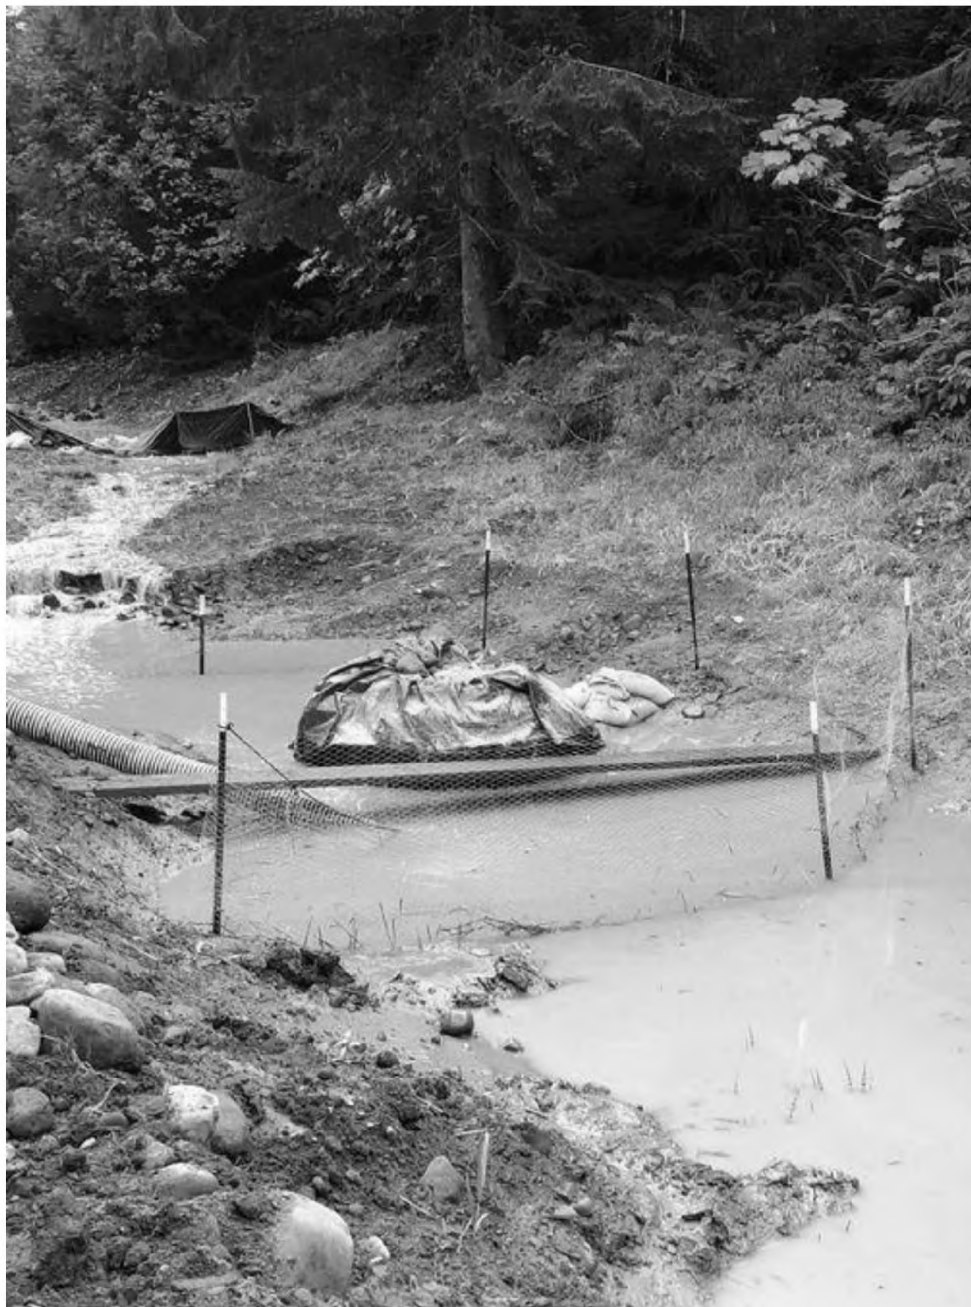
Photo 15

There appeared to be a trickle of water entering the stormwater pond, but not discharging due to capacity. Ecology noted the need to fully plug the outlet pipe within the sediment trap.

Photo Description: Outlet pipe in sediment trap- covered, but plug needs to be checked and maintained
